JEFA RUDDER service tip – self-aligning bottom bearing getting stiffer in time

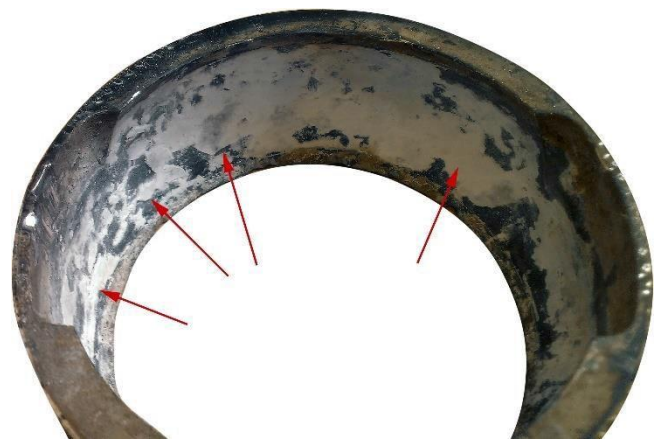
2. Calcium residue (lime) between the outer housing and the bearing ball.

On some boats the bottom bearing is continuous “kissing the water”. As the gap between the outer housing and the bearing ball is very small, water could be sucked up by capillary action. Normally the grease between the ball and housing will prevent this, but after some time of use, heating up and cooling down many times, the grease will run out this area.

The water will evaporate, leaving the calcium residue (lime) and salt behind. In time, the layer will build up in thickness compressing the ball with rollers more and more against the rudder shaft. This will add friction and cause the steering to get stiff. To resolve this, one can replace the outer housing for a new one, or use some acid and a brush to dissolve the calcium (be careful to use acid only for a few minutes, as it will also damage the aluminium in time). The inner spherical surface can also be sanded with very fine sanding paper. When the ball with rollers is still in good shape, it can be placed back, but carefully watch for cracks which could grow in time and cause rollers to fall out. If cracks are present in the top or bottom of the bearing ball, it should be replaced by a new one. Please contact our service staff (info@jefa.dk) for these parts. Also make sure you carefully clean all dirt between the rollers before you put the ball back.

To prevent water entering the area between the bearing ball and outer housing, one can fill this up with a stiff grease. A good grease for this is Lanacote. Any synthetic grease will do the job, as long as it is as sticky and hard as butter. **Please make absolutely sure no grease gets on, or between the rollers!**
