JEFA RUDDER service tip – self-aligning bottom bearing getting stiffer in time

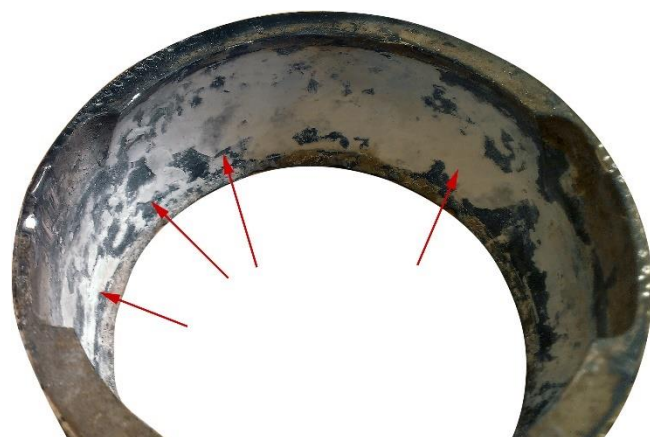
2. Calcium residue (lime) between the outer housing and the bearing ball.

On some boats the bottom bearing is continuous “kissing the water”. As the gap between the outer housing and the bearing ball is very small, water could be sucked up by capillary action. Normally the grease between the ball and housing will prevent this, but after some time of use, heating up and cooling down many times, the grease will run out this area.

The water will evaporate, leaving the calcium residue (lime) and salt behind. In time, the layer will build up in thickness compressing the ball with rollers more and more against the rudder shaft. This will add friction and cause the steering to get stiff. To resolve this, one can replace the outer housing for a new one, or remove it from the hull and submerge it in an acid which will dissolve the calcium. The inner spherical surface should not be scratched or sanded. When the ball with rollers is still in good shape, it can be placed back, but carefully watch for cracks which could grow in time and cause rollers to fall out. If cracks are present in the top or bottom of the bearing ball, it should be replaced by a new one. Please contact our service staff (sales@jefa.com) for these parts. Also make sure you carefully clean all dirt between the rollers before you put the ball back.

To prevent water entering the area between the bearing ball and outer housing, one can fill this up with a stiff grease. A good grease for this is Lanacote. Any synthetic grease will do the job, as long as it is as sticky and hard as butter. **Please make absolutely sure no grease gets on, or between the rollers!**
