## Re-adjusting (re-shim) the RP100 gears.

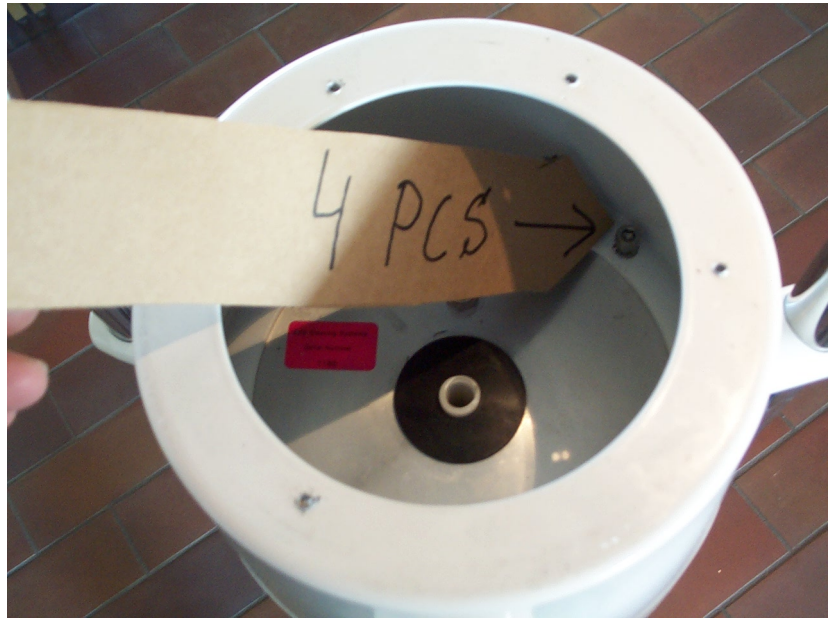
Remove the compass and the 4 nuts holding the compass binnacle.

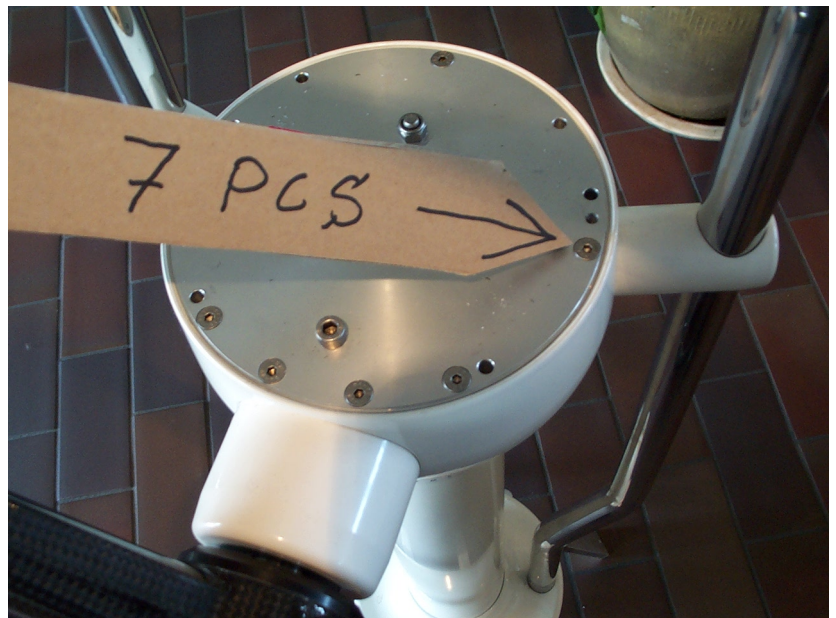
Remove the 7 bolts holding the top cover.

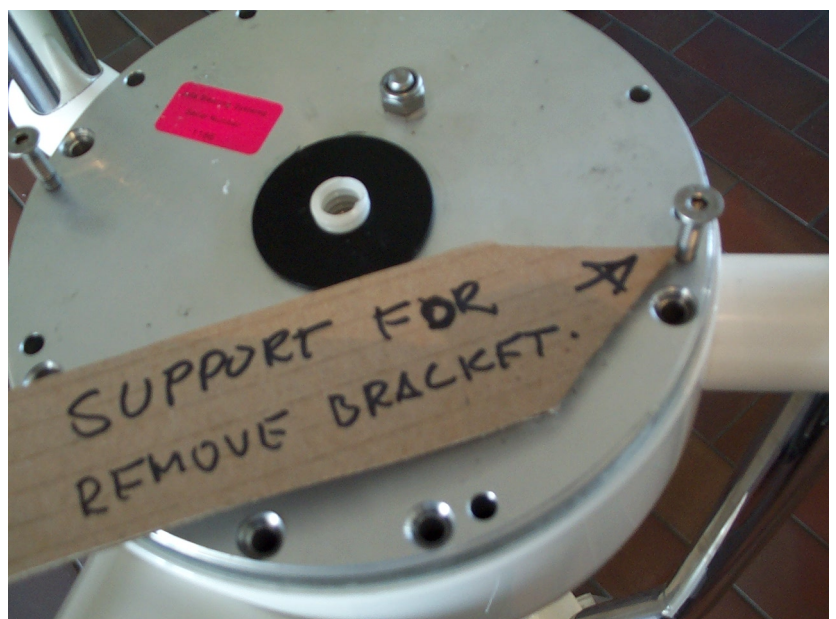
The top cover can be pushed upwards by screwing in 2 bolts like shown and screwing them inwards. The cover will come upwards.

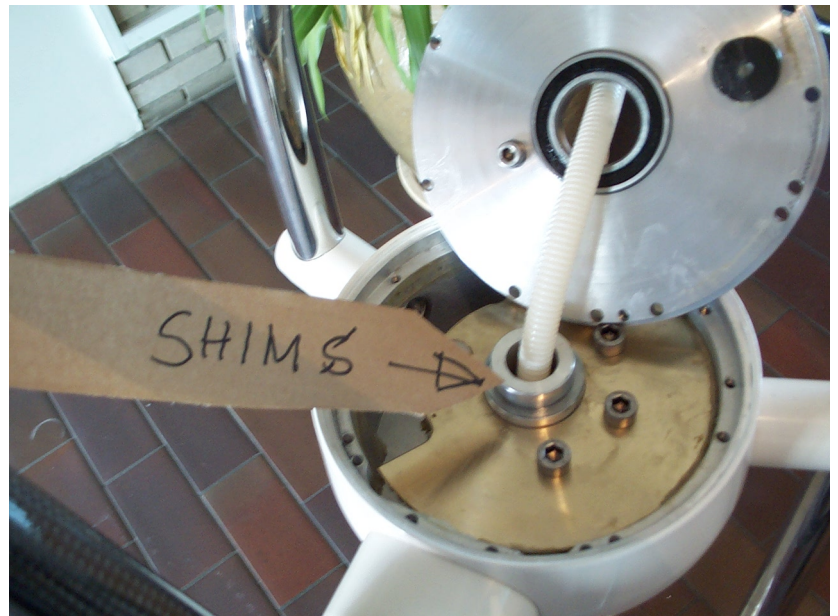
Add one 0,1 mm thick shim and put the cover back on, tightening it with 2 bolts. Rock the wheel sideways to determine if all backlash is gone. If not, add another shim. When the steering shaft is not rotatable by hand force, you have added too many shims.

After the final shimming is done, remount the top cover and binnacle.
